Preliminary Results of Post-Disaster Archaeological Investigations at the Char Narayan Temple and within Patan's Durbar Square, Kathmandu Valley UNESCO World Heritage Property (Nepal)

Coningham, R.A.E.¹, Acharya, K.P.², Davis, C.E.¹, Kunwar, R.B.³, Tremblay, J.C.¹, Simpson, I.A.⁴ and Schmidt, A.¹

2. Earthquake Damaged Monuments in Patan's Durbar Square

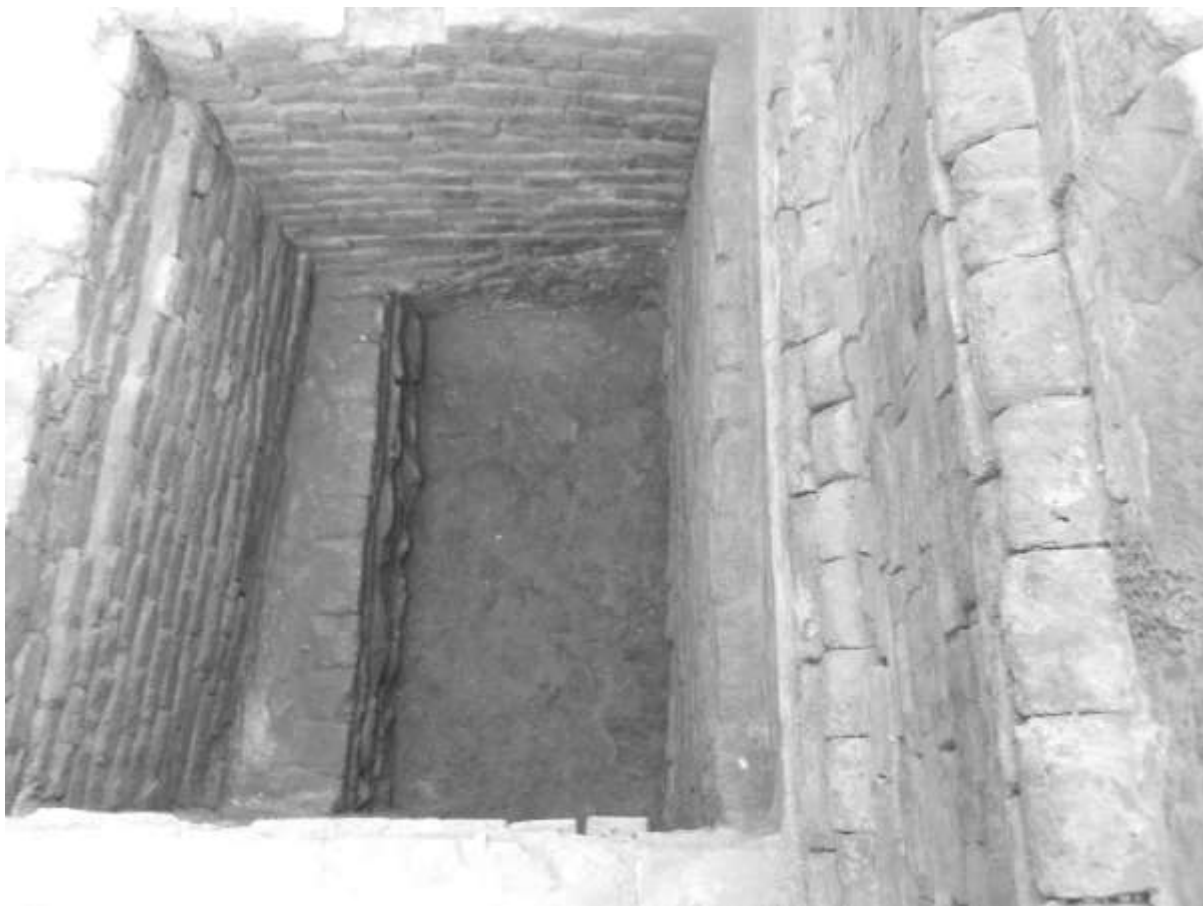
Our investigations have also provided the first published indications of how the foundations of the Char Narayan Temple were configured. Similar to those exposed within the cuttings undertaken by KVPT on the western platform edges of the Char Narayan Temple, which are yet to be published (Figure 20) (Coningham et al. 2016c) and those at the Vatsala Temple in Bhaktapur's Durbar Square (Coningham et al. 2016b), the brick walls rested on stone cobble foundations. Preliminary results from the GPR survey indicate wall stumps within this platform and indications from the subsurface interventions next to the foundations suggest that the platforms of the temple may have been formed through bracing cross-walls, similar in plan to those exposed by the rescue excavations at Kasthamandap (Coningham et al. 2016a). However, further processing of the GPR survey data is required as well as further investigations of the platforms through formal archaeological excavation to fully substantiate this postulation. However, it must be emphasised again that any subsurface investigation that is undertaken requires scientific excavation and systematic recording of the soil and artefacts that are removed as well as the masonry that is exposed.

Figure 20: Stone cobble foundations visible in trench cleaned by the team that was left open by KVPT on the western side of the Char Narayan Temple, looking north.
